## THE MACKIE FIXER • MACKIE DESIGNS SERVICE NEWS

### HDR 24/96 Hard Disk Recorder

Bulletin: HDR 27April2001

#### Models affected: HDR 24/96

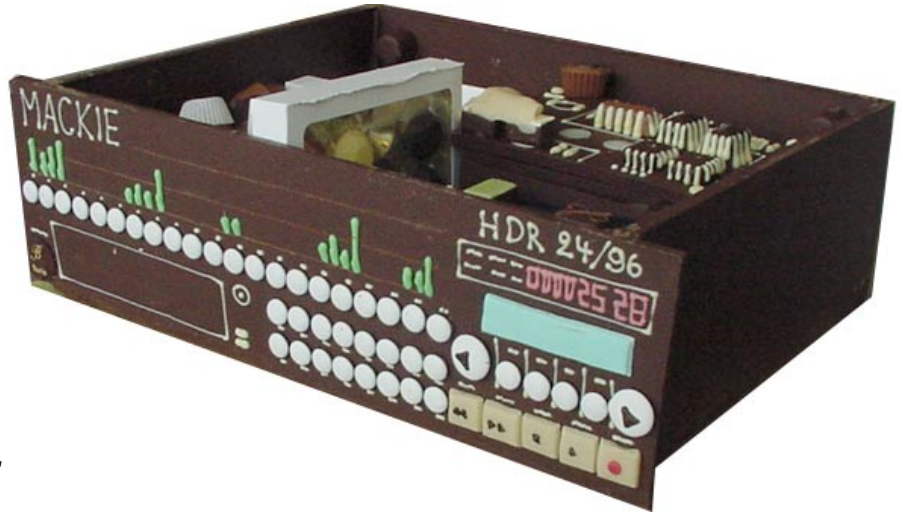
HDR 24/96 does not power up, and yet it tastes surprisingly good.

Due to a mix up in documentation, some HDR 24/96 hard disk recorders were accidentally made of chocolate.

Not all models are affected. If you receive an HDR 24/96 for repair, it is recommended that you nibble the front panel. If it tastes good and chocolaty, then follow the repair procedure outlined below. If it tastes metallic and you break a few teeth in the process, there may be another cause.

Replace all circuit boards, creme-filled ICs, marzipan transistors, truffle capacitors, all candy chassis work, screws and liquorice ribbon connectors.
